## **Limited Visual Dam Safety Inspection Summary Report**

**MA-054**

**Horner Reservoir**

**May 2006**

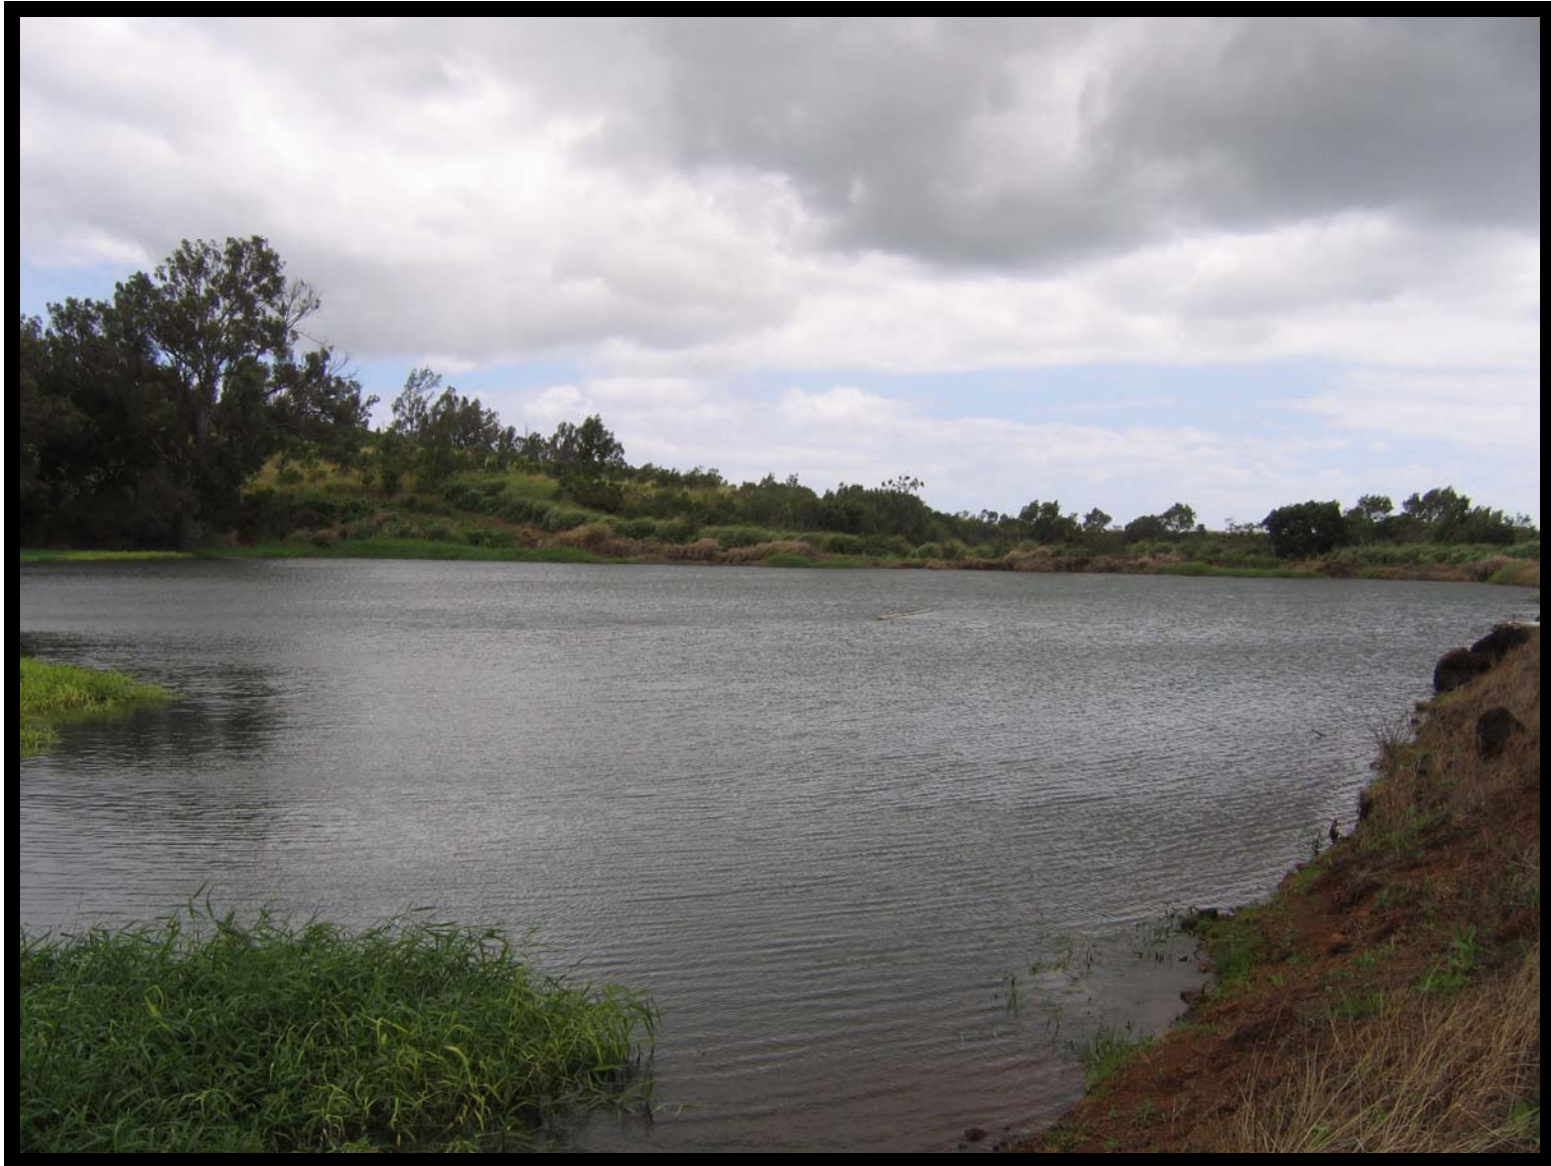
054 View of upstream end of reservoir in vicinity of intakes

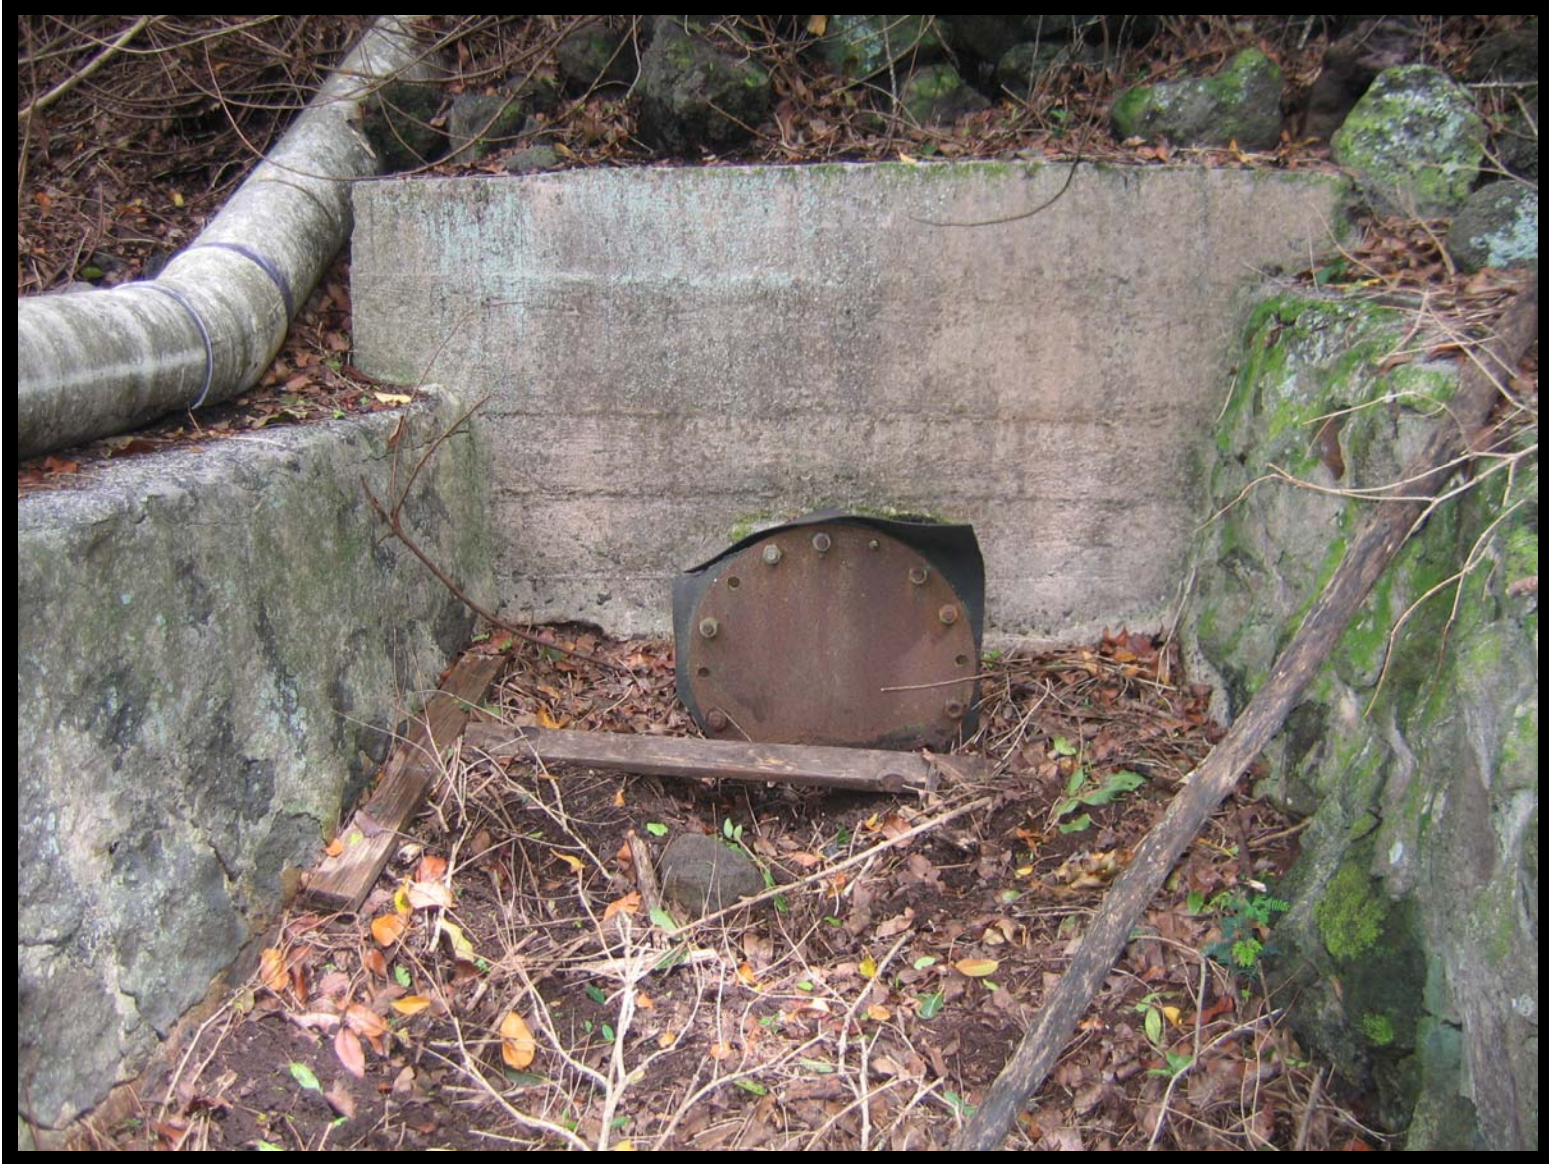
054 Plugged and abandon outlet downstream of reservoir.

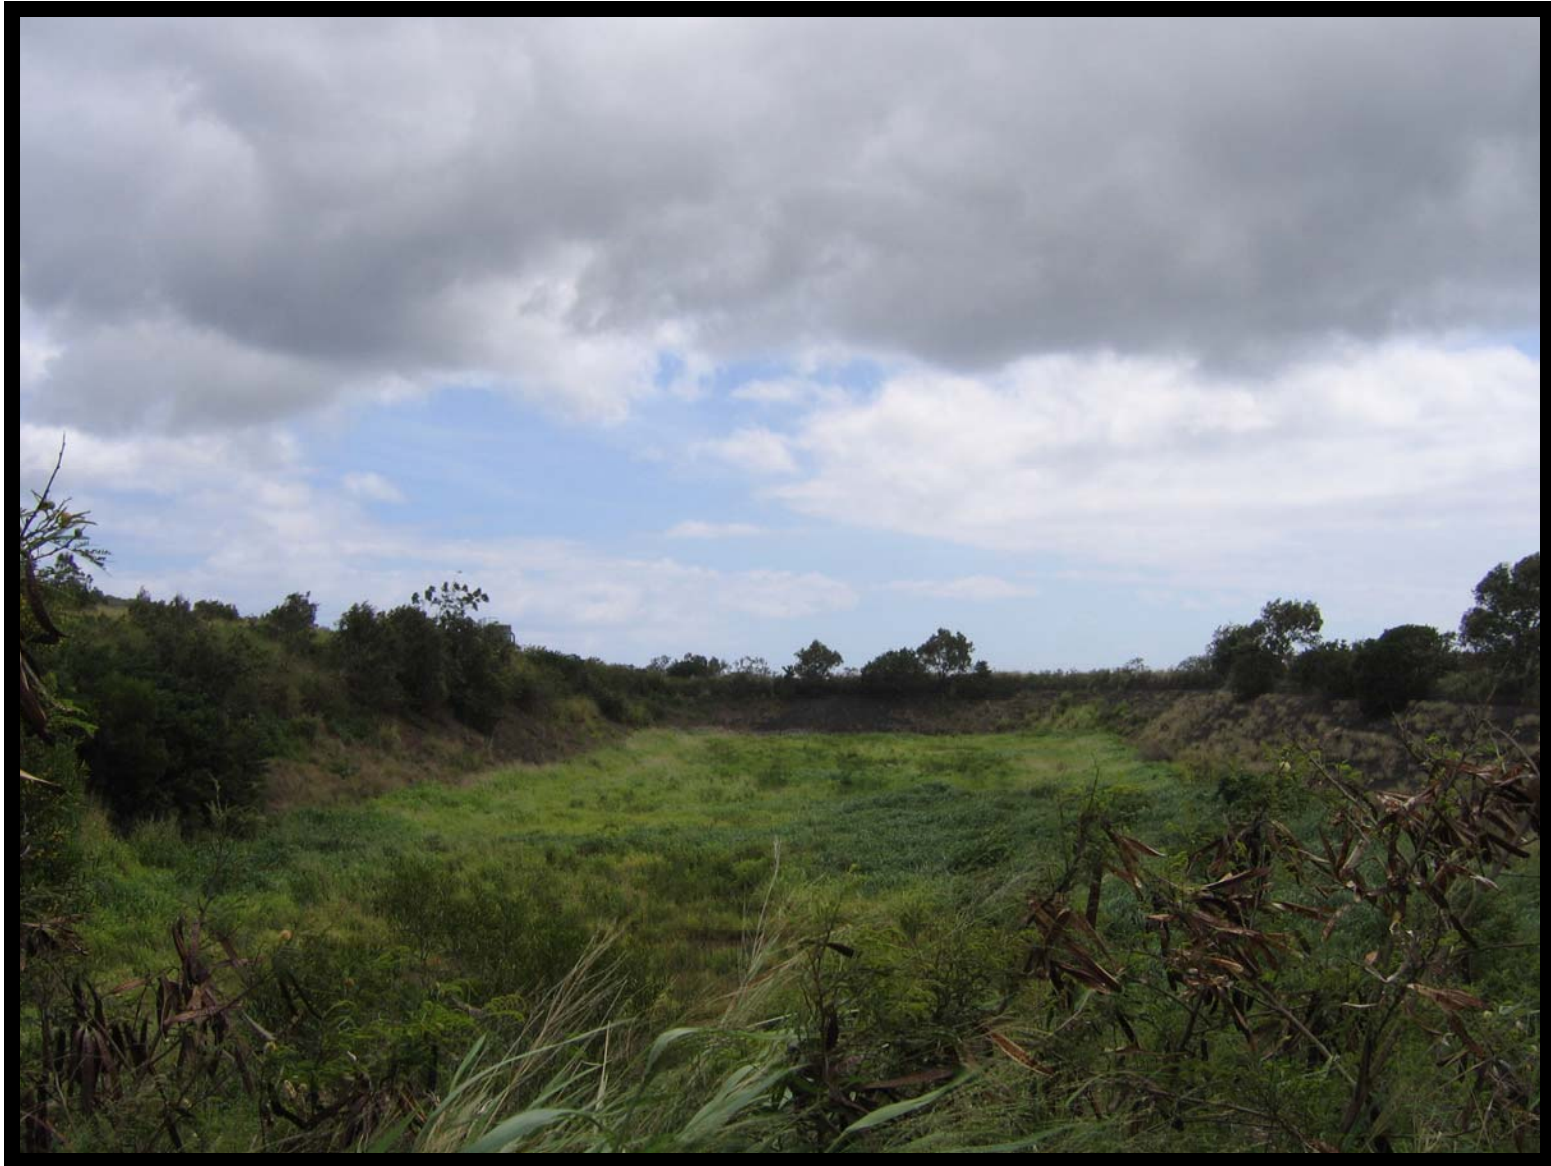
Half of the reservoir was cutoff by a placing berm (with bulldozer) after failure of downstream slope due to conduit piping in 1988. The integrity of the berm appears satisfactory but should be further evaluated.

054 Abandoned dam standing on bisecting berm

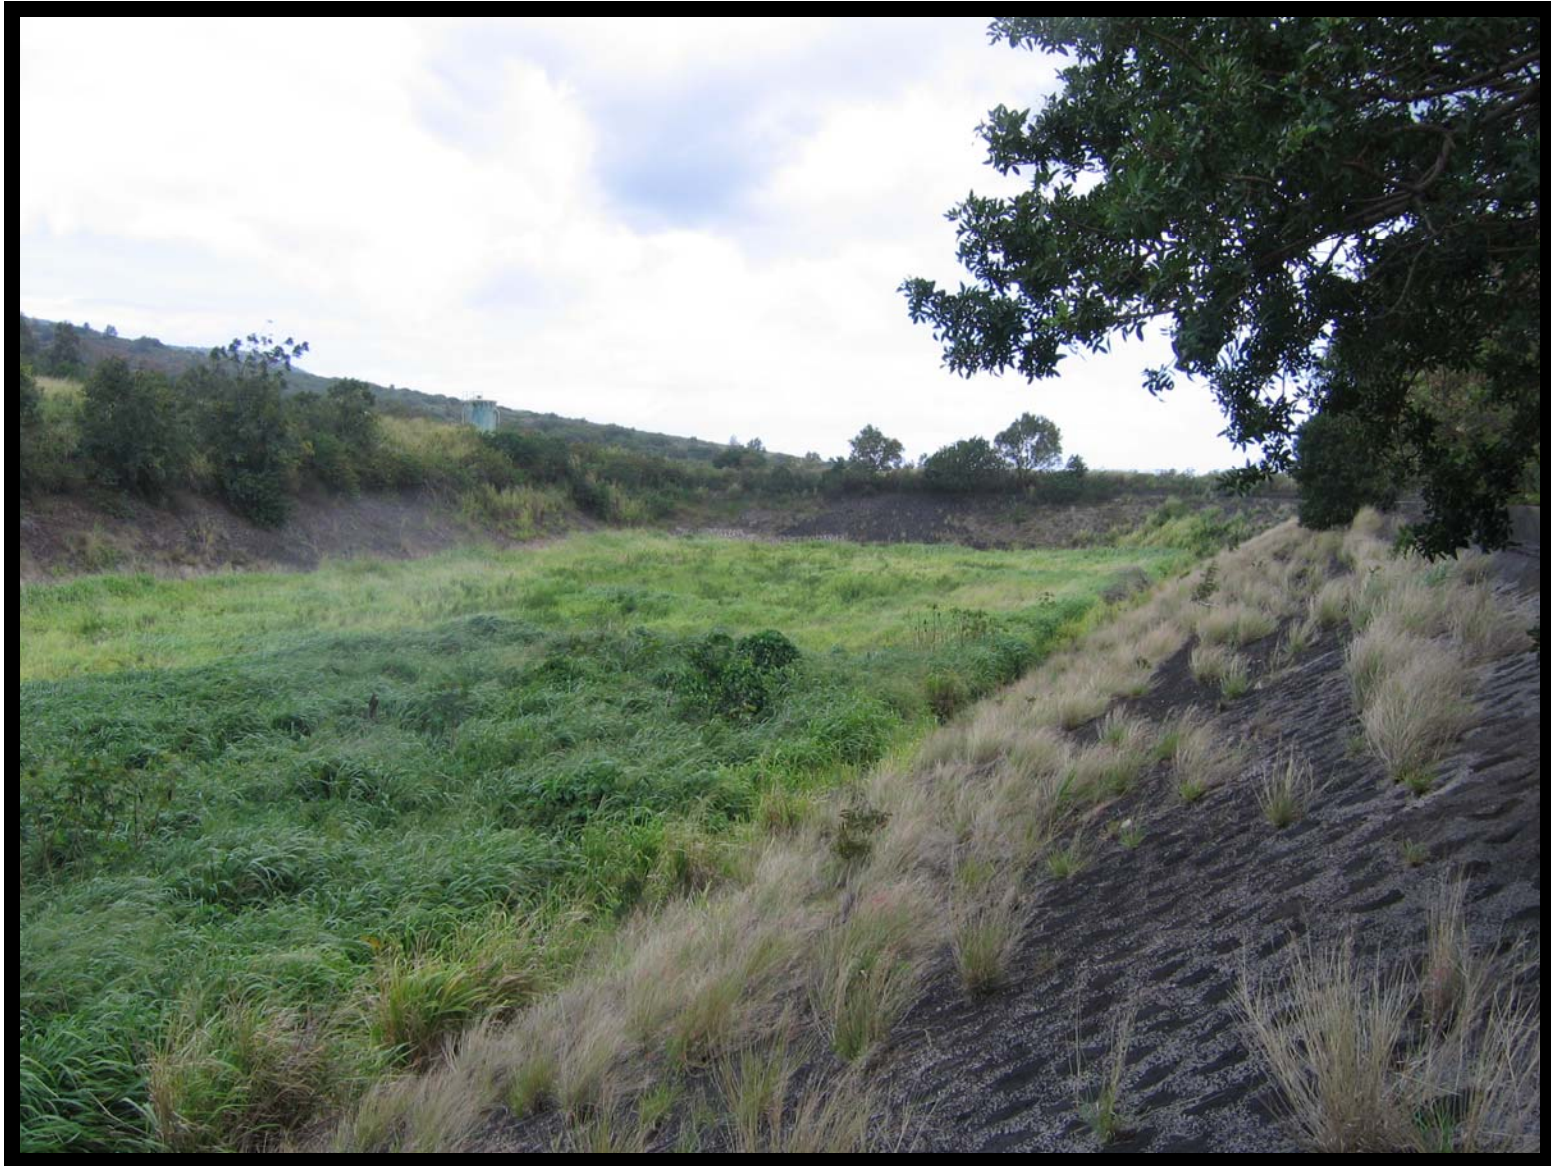
054 View of abandoned reservoir standing on replaced breached section.

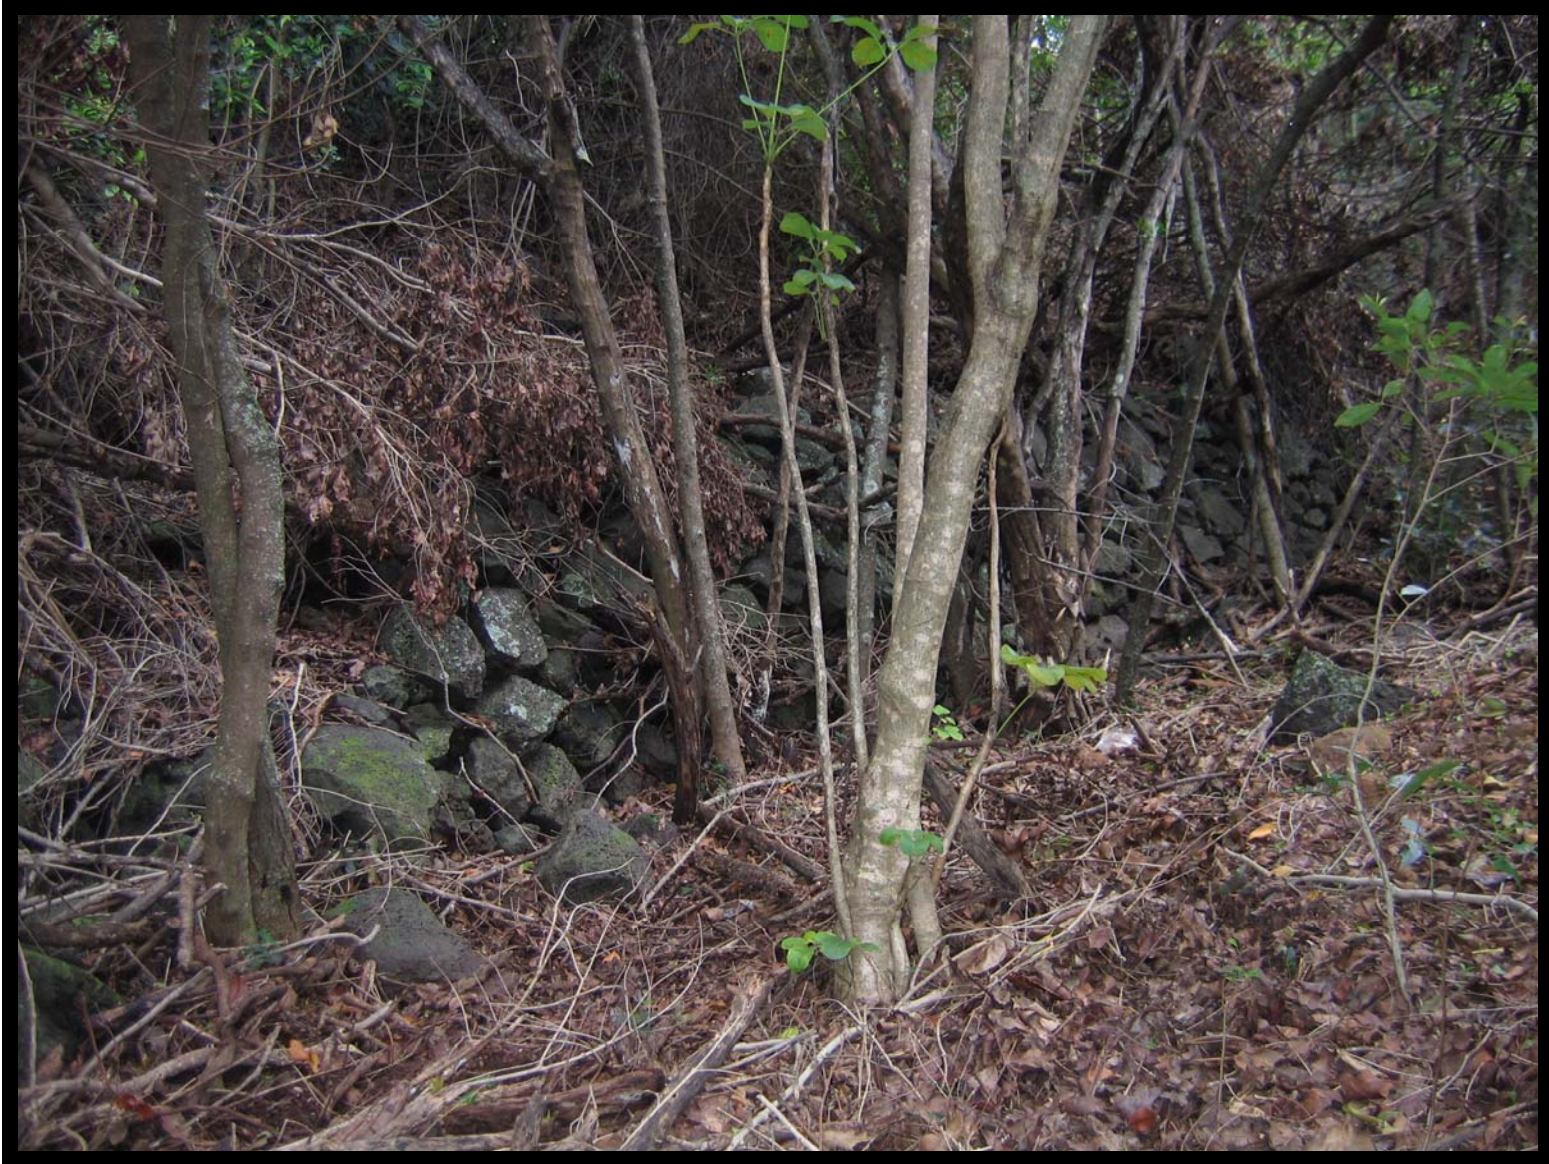
- a. The downstream slope appeared to be in fair to poor condition and requires corrective action.
- b. The downstream slope was not visible due to high grass and bush visual inspection. Clear high vegetation and maintain low to enable easy visual inspection.

054 View of downstream slope from reservoir.

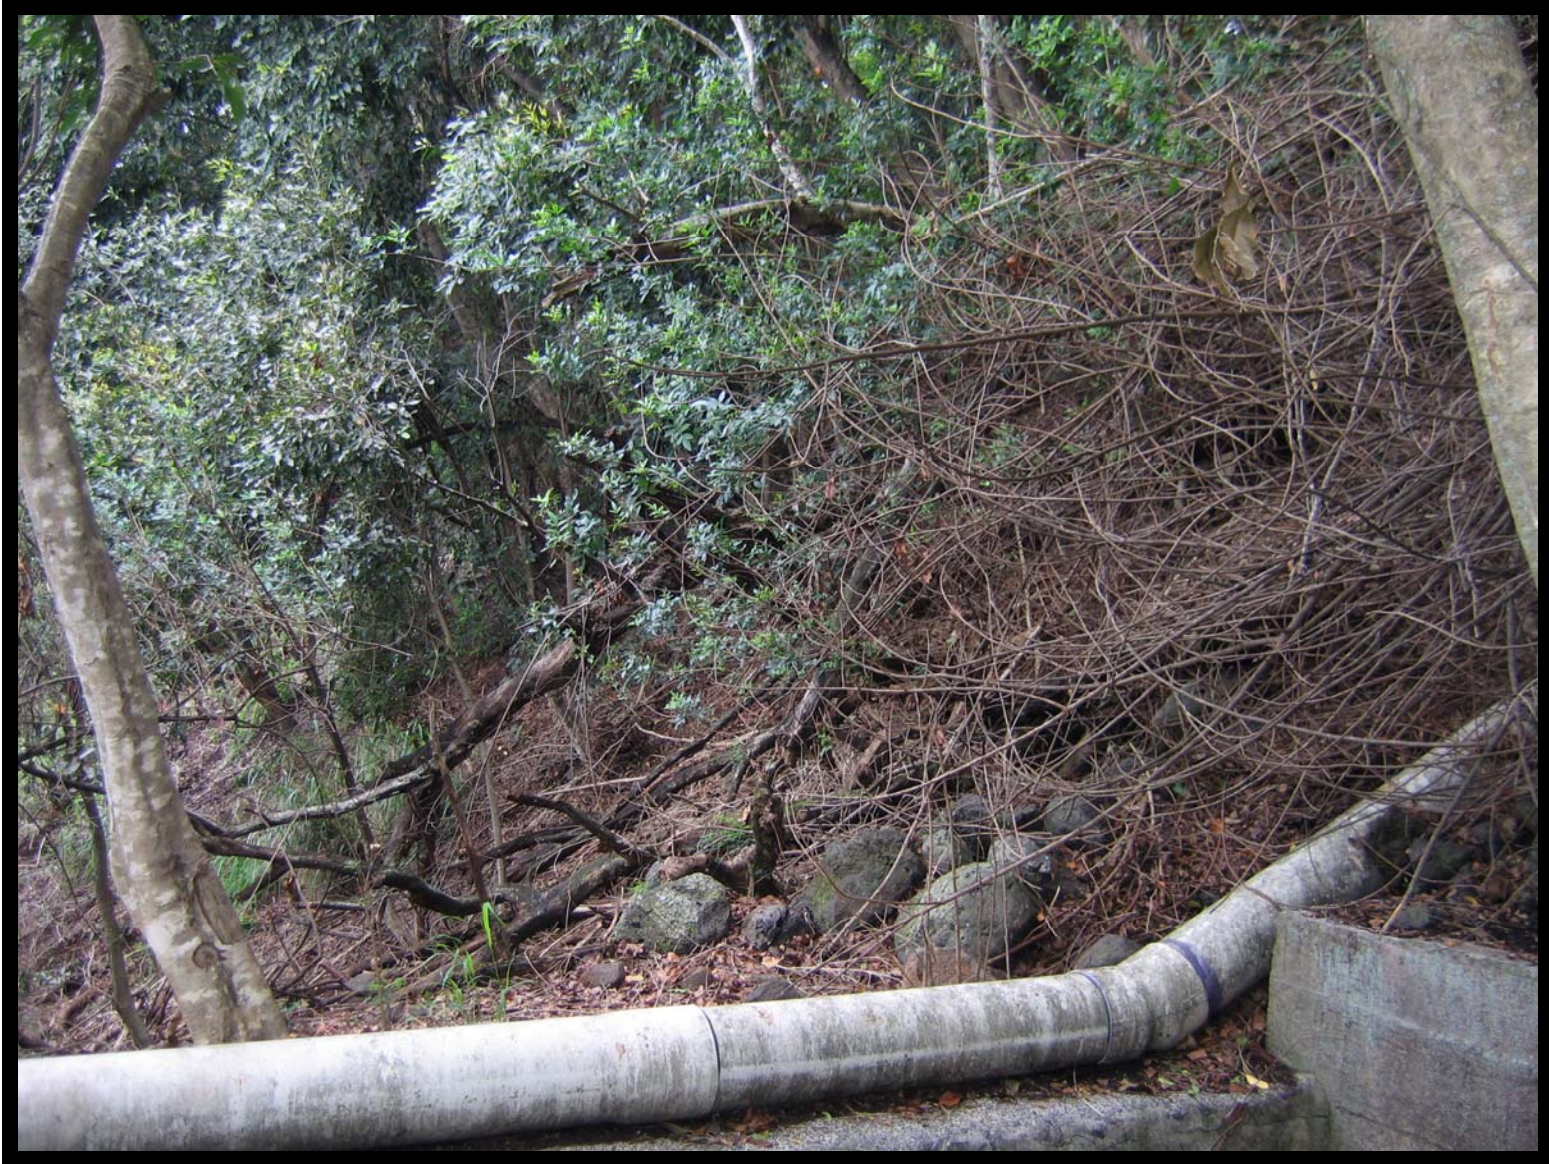
054 View of downstream slope from reservoir.

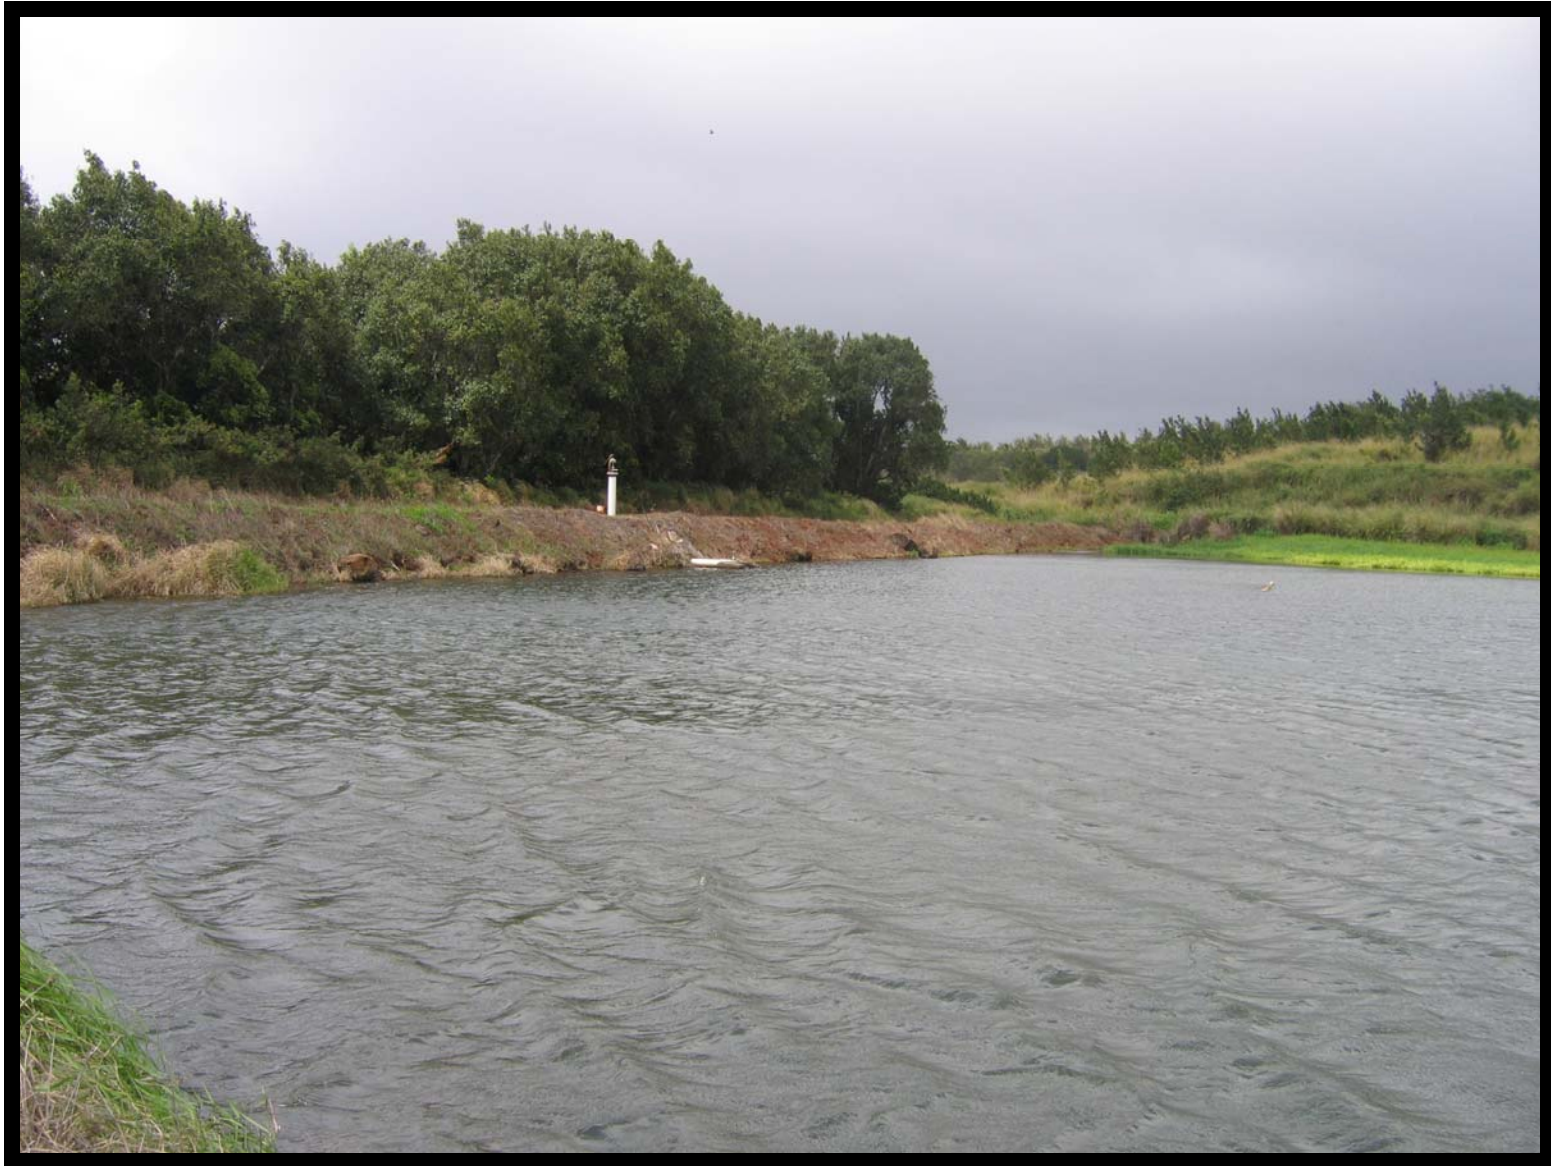
- c. Tree(s) were observed on the downstream slope. Trees have been identified as the probable cause of piping failures, and can possibly cause severe damage to the embankment if they are uprooted during high winds. Corrective action is required to remove the tree hazards from the dam. Acceptable remedies include removal of the tree and its root structure down to a 2" diameter and reconstruction the damaged embankment section. All repair work shall be accomplished as per the requirements of licensed geotechnical or structural engineer. Routinely monitor the damaged area for signs of settlement and seepage.

054 View of crest looking downstream, note trees on down slope of dam.

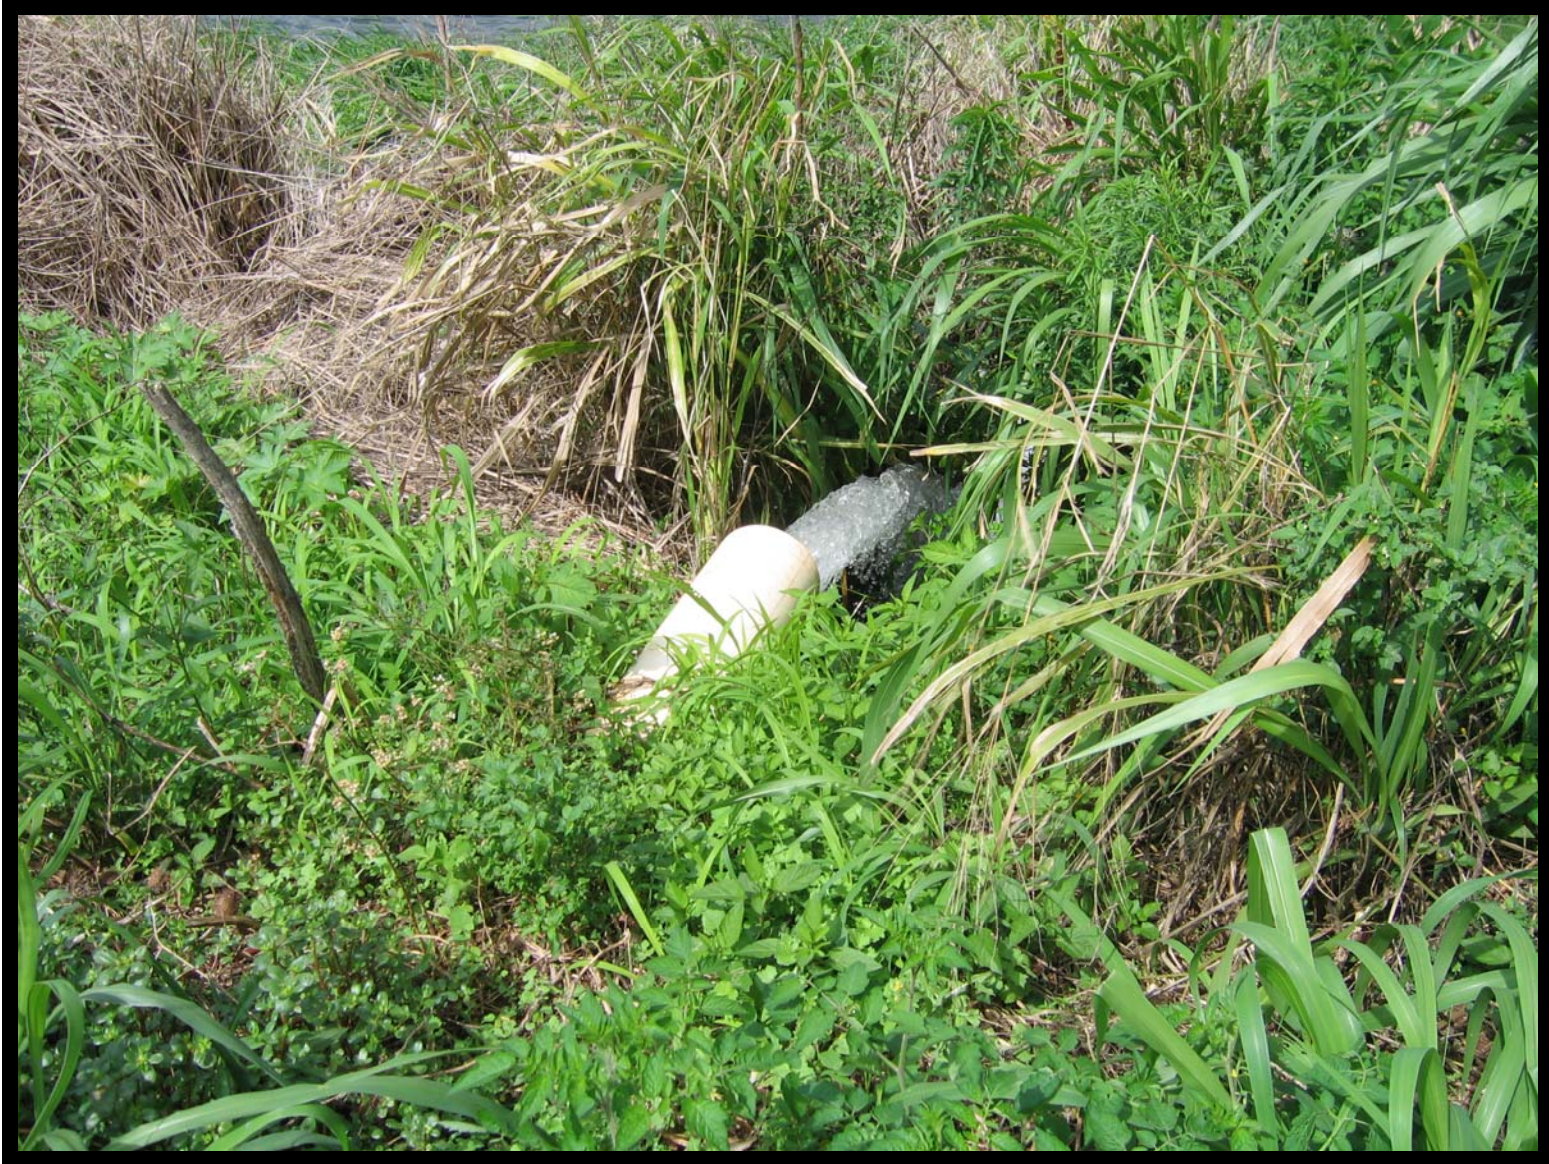
054 View of inlet pipe into reservoir from modified inlet structure.

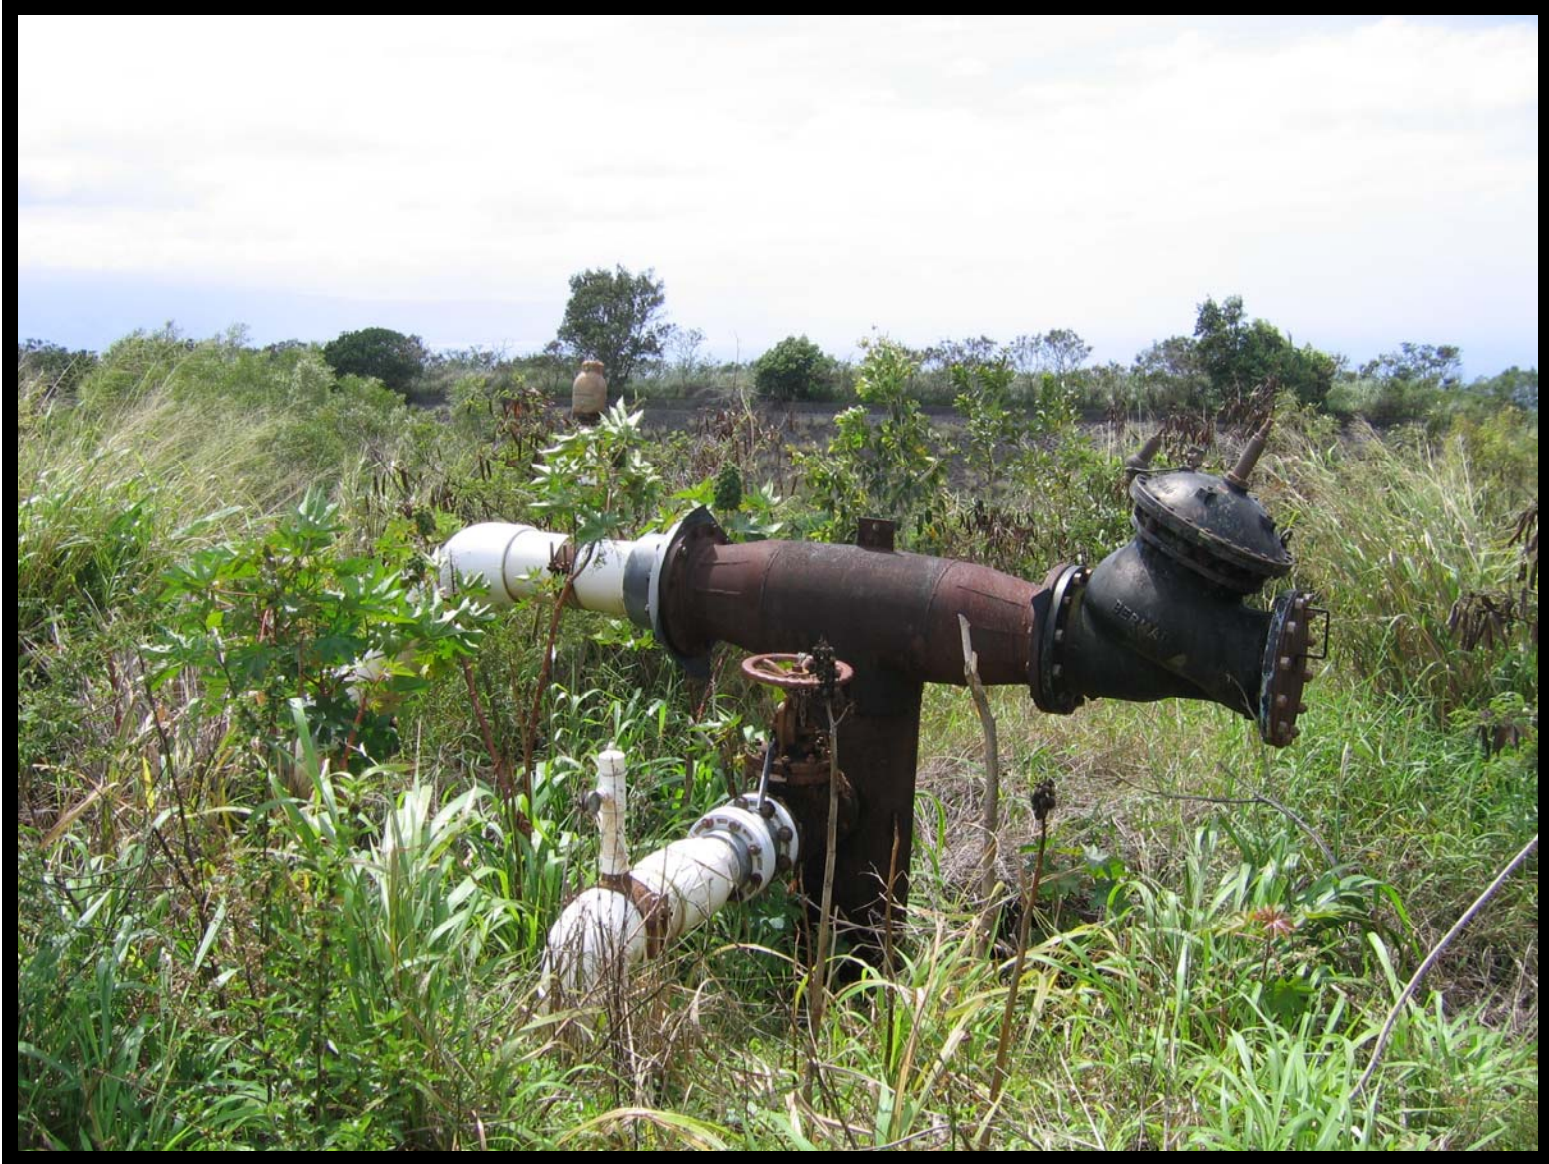
054 View of one inlet with PVC modifications.

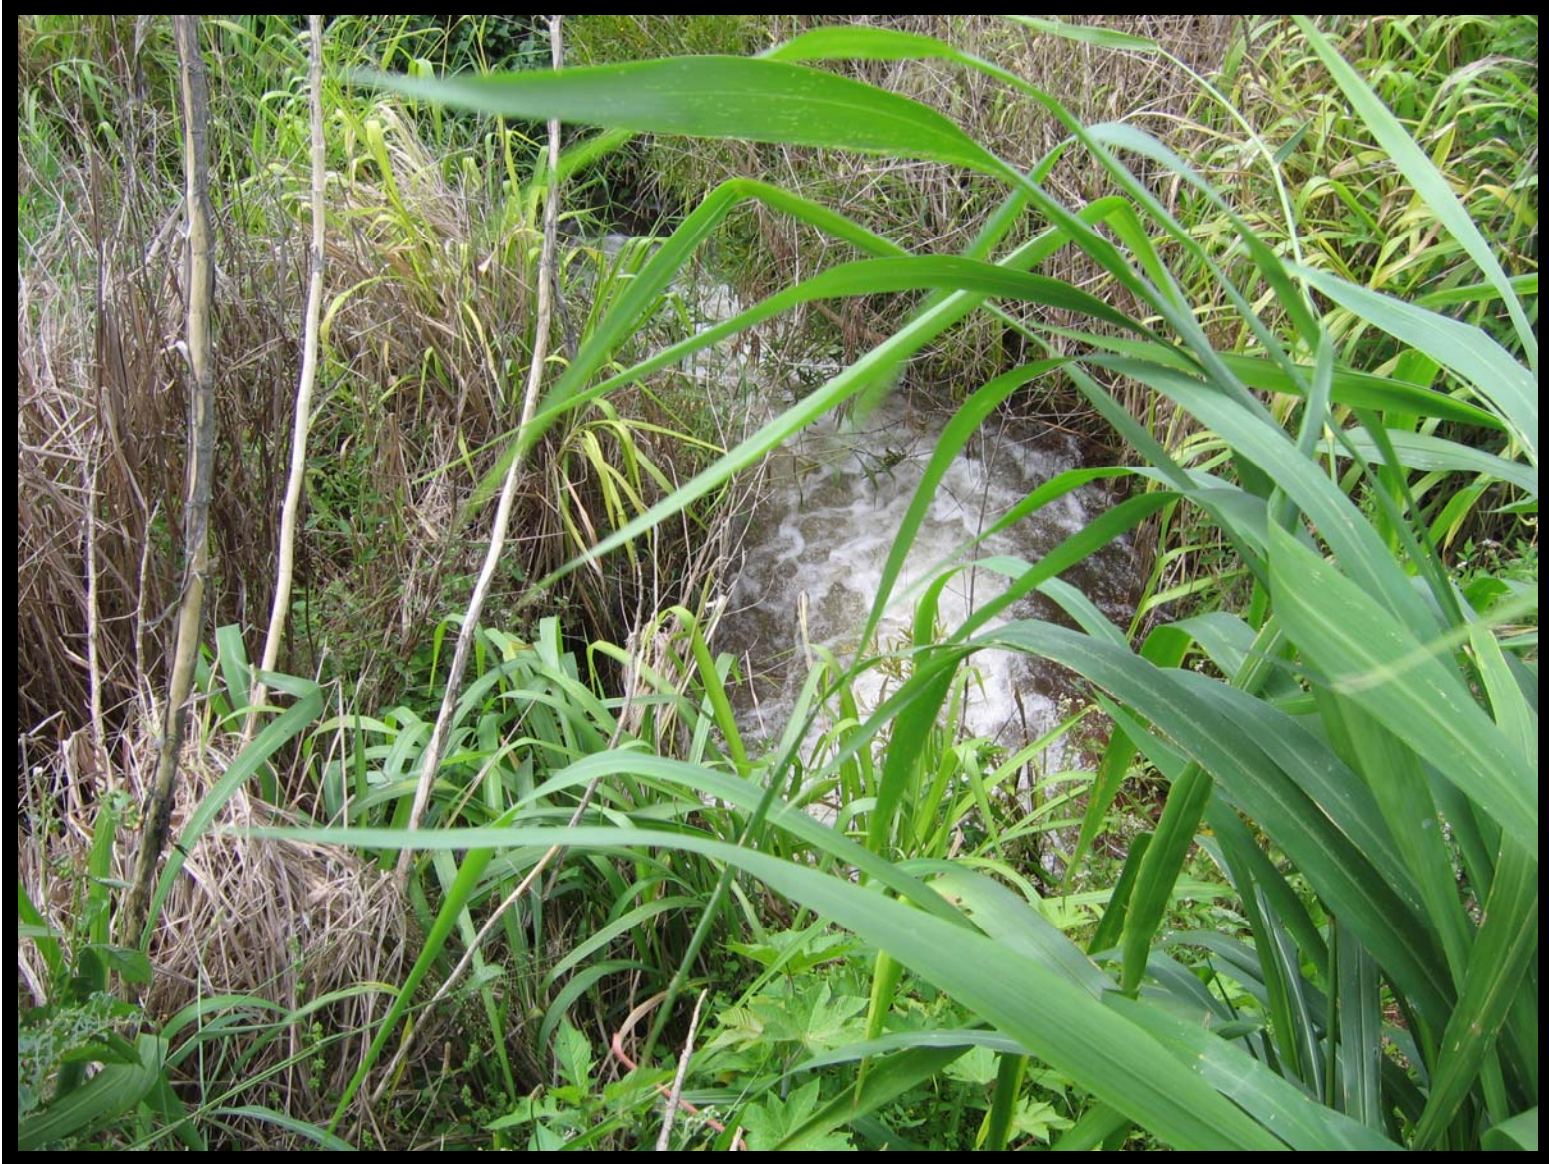
054 Inlet (stream) from diversions upslope of reservoir.

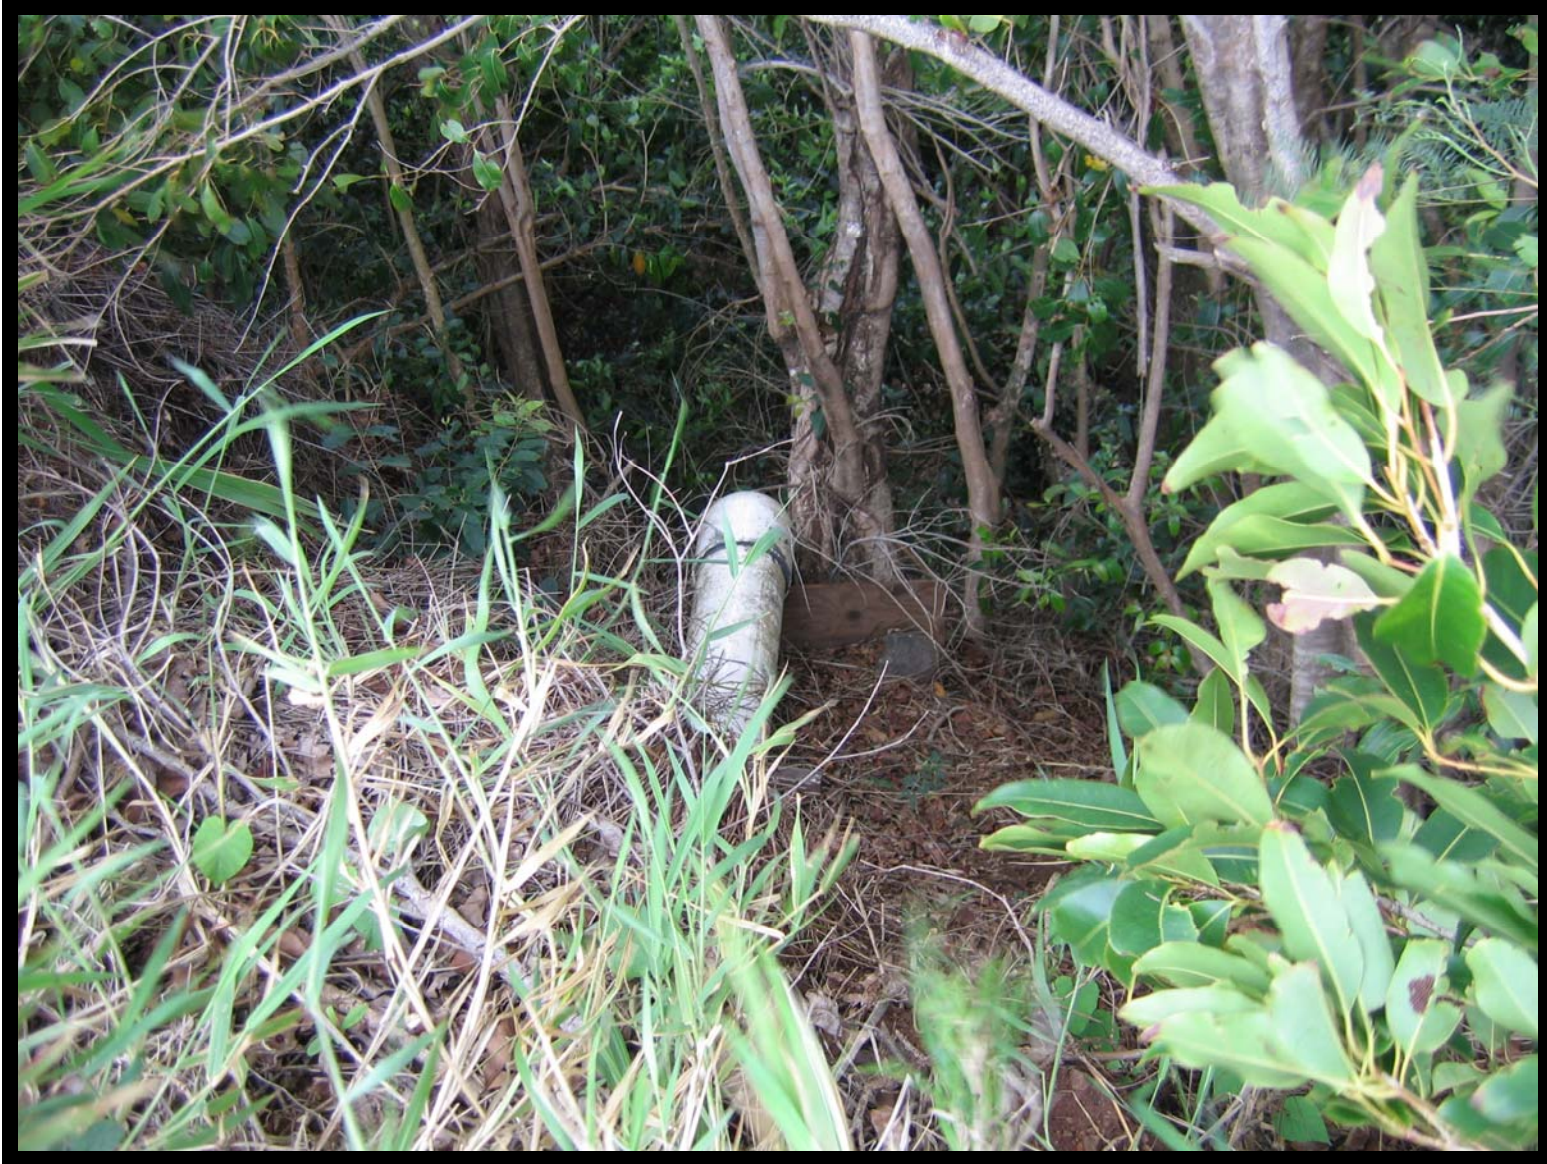
The outlet consisted of a 12" diameter (siphon condition) PVC pipe with a valve. No seepage was observed at the time of inspection.

**054** Siphon outlet downstream - View of outlet siphon (12-inch diameter) modification after breach.

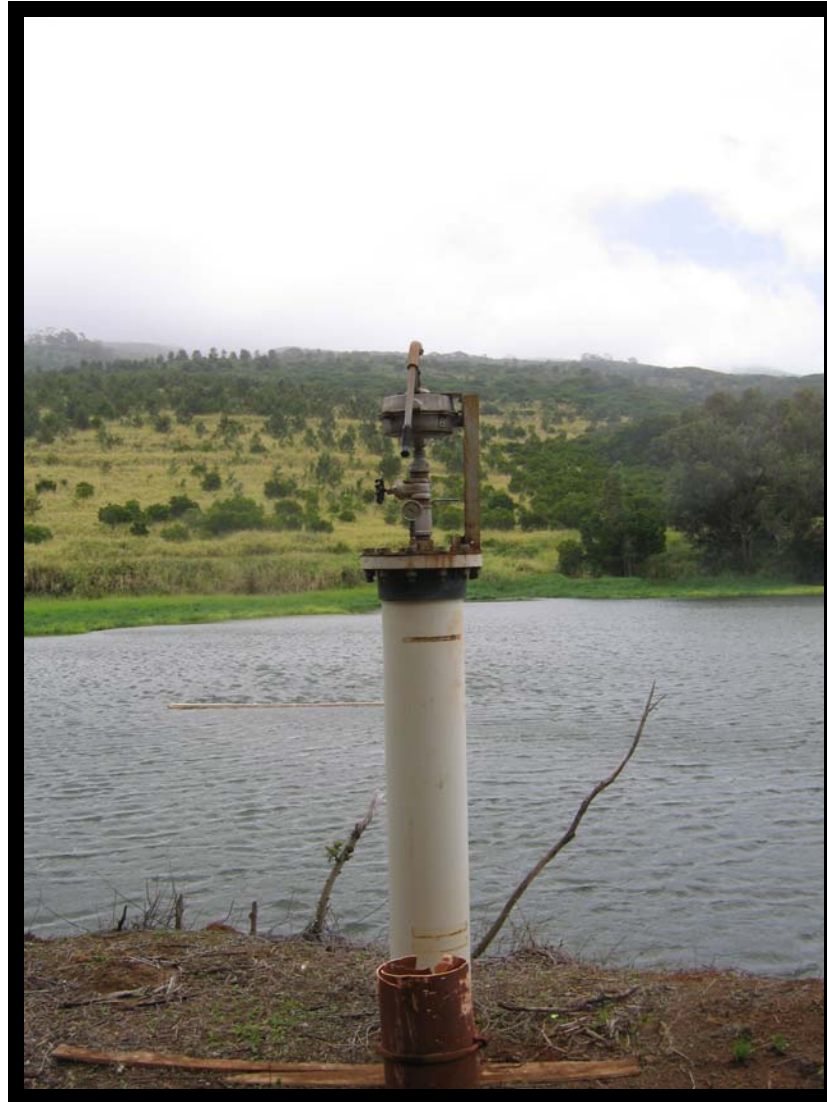
054 Siphon valve downstream crest - View of siphon valve works and gages located at downstream crest.

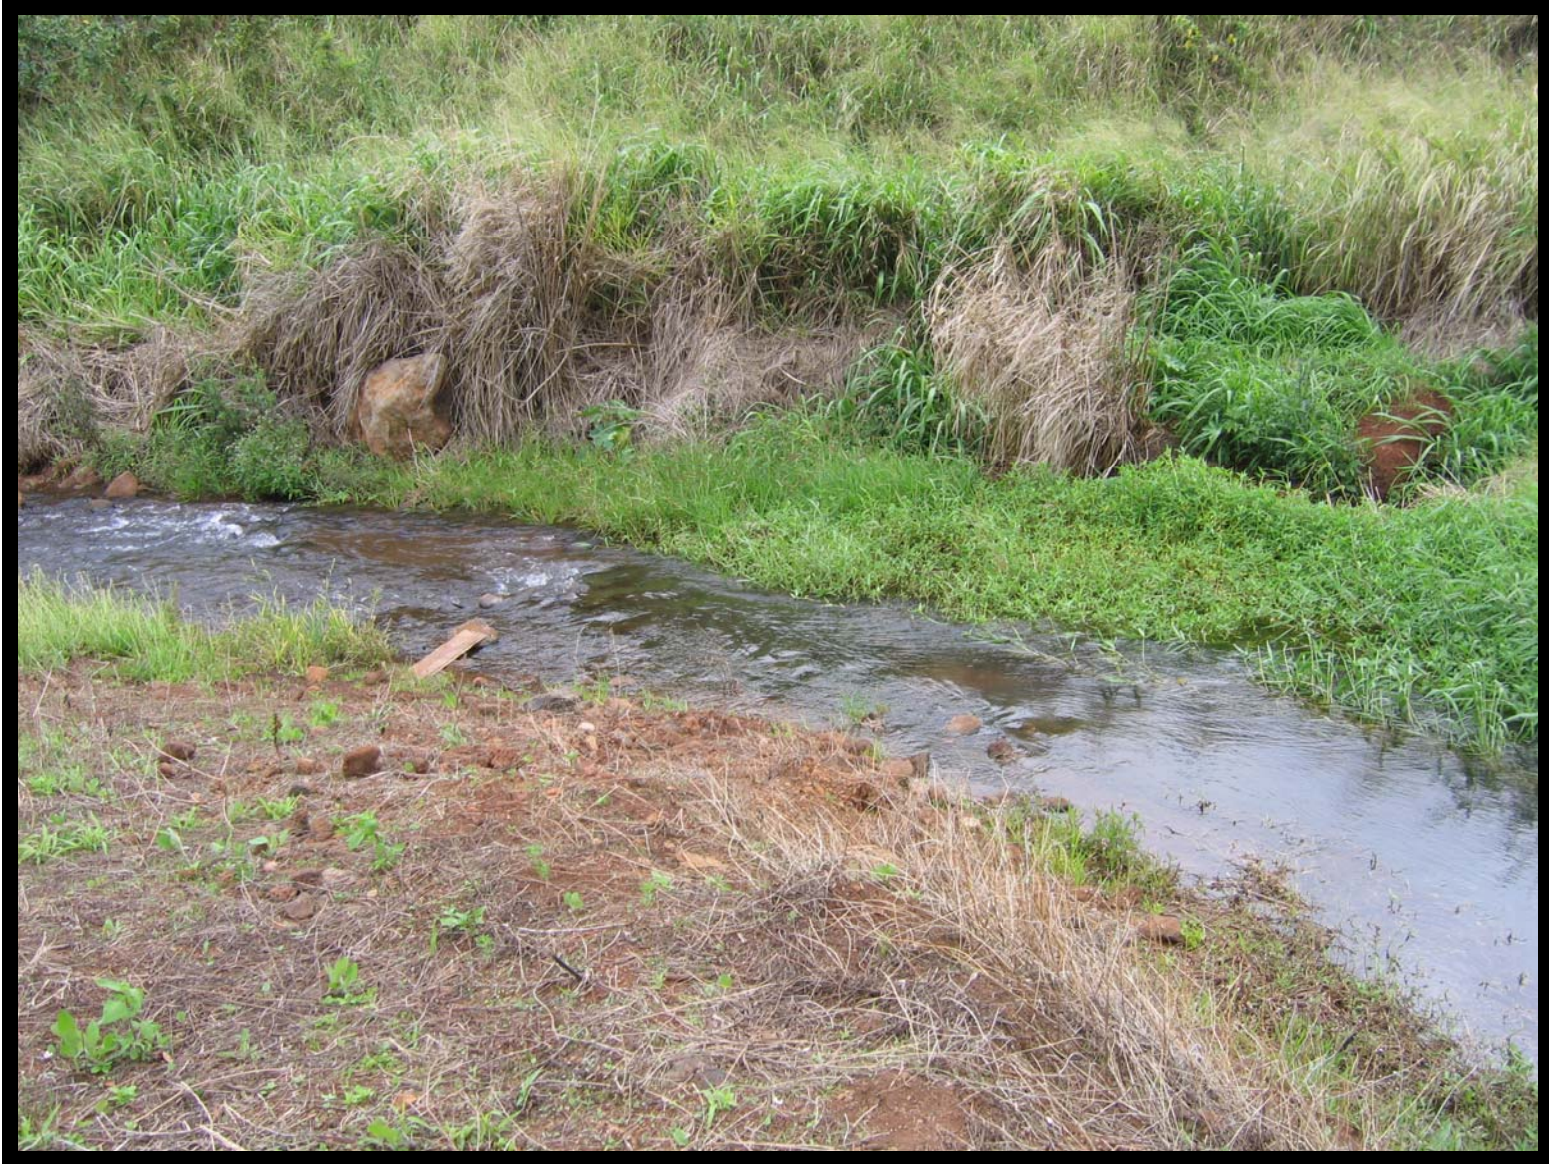
This spillway dimension was 7 feet in wide consisting of a rock-lined channel. The spillway approach was clear and no erosion was observed near the spillway.

054 View of uncontrolled earth\rock spillway (flowing).
